# Towards development of a risk management tool for roads affected by dryland salinity.

**G. J. Street**

## SUMMARY

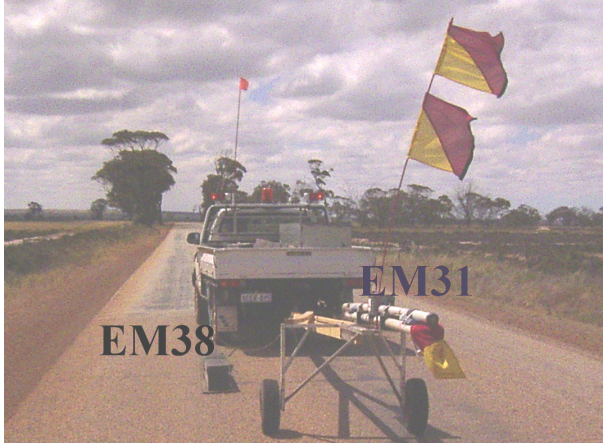
**Figure 1. EM equipment towed behind a vehicle on a country road in Western Australia.**

Shallow penetrating EM instruments such as the Geonics EM38 and EM31 (McNeil, 1980) have the potential to map conductivity distribution within the road pavement and within the underlying subgrade. These instruments can be towed behind a vehicle (Figure 1) and profiles of road conductivity can be measured at speeds up to 30 km per hour allowing long sections of roads to be traversed. The relationships between EM conductivity and salinity have been explored elsewhere (McNeil, 1980; Broadfoot et al., 2002). Local tests around areas of distorted pavement (Figure 2) also indicated there were lateral differences in conductivity across the road (Street and Petrusma, 2004).

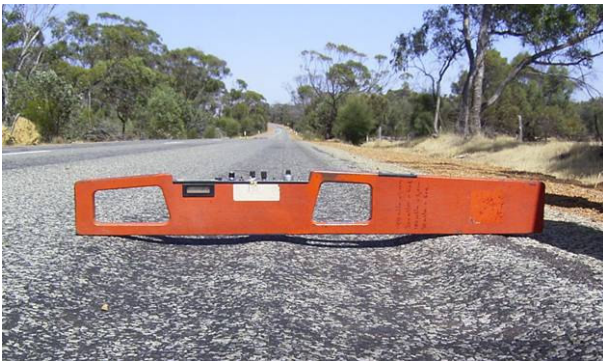
**Figure 2. An EM38 meter sitting on a severely rutted rural road.**
